# INVESTIGATION OF SLUMPING FAILURE IN AN EARTH DAM ABUTMENT AT KOTZEBUE, ALASKA

Charles M. Collins and Terry T. McFadden

July 1977

Prepared for  
U.S. PUBLIC HEALTH SERVICE  
By  
CORPS OF ENGINEERS, U.S. ARMY  
COLD REGIONS RESEARCH AND ENGINEERING LABORATORY  
HANOVER, NEW HAMPSHIRE

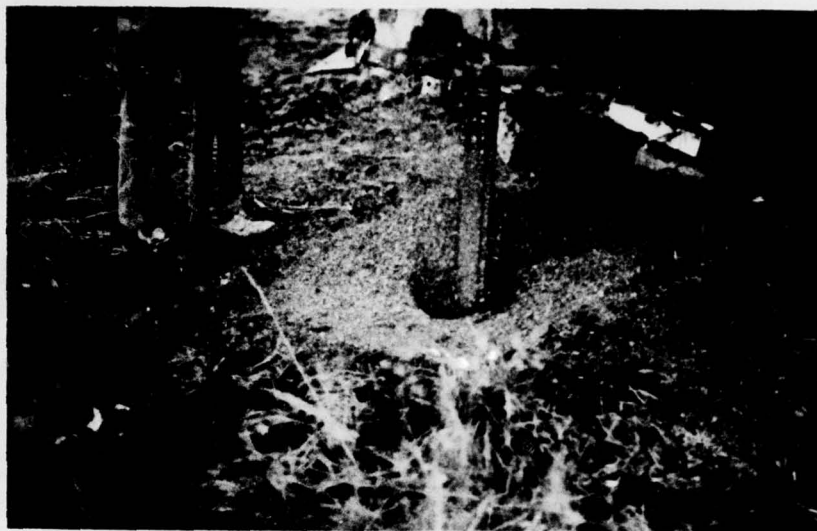
*Figure 6. Thermocouple hole being drilled in the crest of the dam. Note the extensive amount of clear ice being extracted from the hole.*

In August 1976, Jim Thrasher and Associates drilled seven 80-ft holes (Fig. 6) on the dam crest adjacent to and through the southern abutment (Fig. 2, holes 5-11). Thermocouple assemblies were installed with thermocouples at 10-ft (3-m) intervals to a depth of 80 ft (24 m).

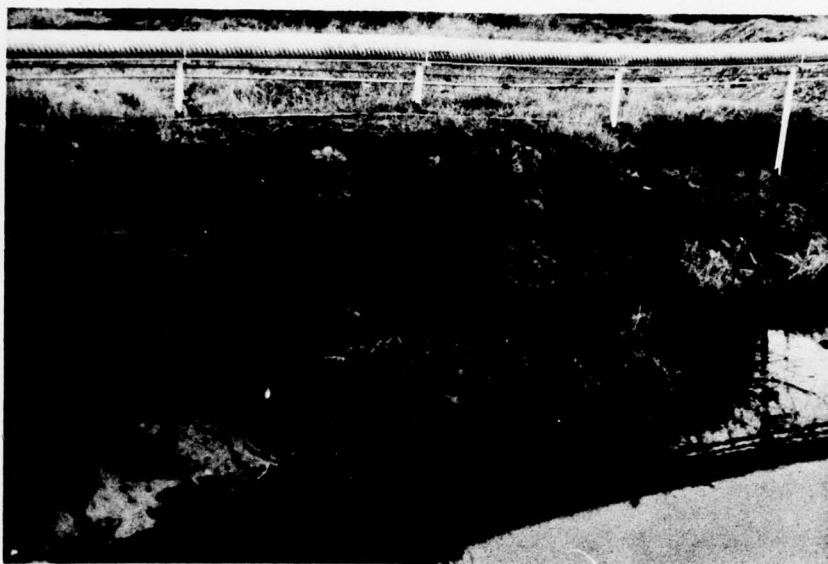
The drill logs (Fig. A5-A11, App. A) and the thermocouple readings (Table I) show that the dam construction has not disturbed the natural permafrost. Except in the reservoir, all of the material below 2 to 3 ft (0.6 to 1 m) from the surface was frozen. In many of the holes a large amount of massive ice was present [over 20 ft (6-m)]; some of it was very near the surface. This ice was present before the dam was built. However, melting is taking place along the steep, unprotected vertical face of the south dam abutment on the upstream side. Melting of these massive ice

structures is causing the silty soil to slump and collapse. Wave action then contributes further by eroding away the collapsed material.

*Figure 7. View of slumping abutment.*

1. The upstream side of the embankment at the south abutment of the dam should be refilled to bring the slope to a much shallower configuration, something approximating that of the man-made embankment (Fig 10 and Fig. B5, App. B) a few yards to the north. This will involve hauling in several hundred cubic yards of embankment fill, such as clean gravel, which is not frost-susceptible. This should be done with the water at the lowest possible level so that the resloping can be as effective as possible. Particular care should be taken to protect the pole foundation under the west end of the bridge carrying the water conduit between the south abutment and the intake structure.

The addition of a hard riprapping material on top of the fill would be good practice and would help to avoid any further erosion due to wave

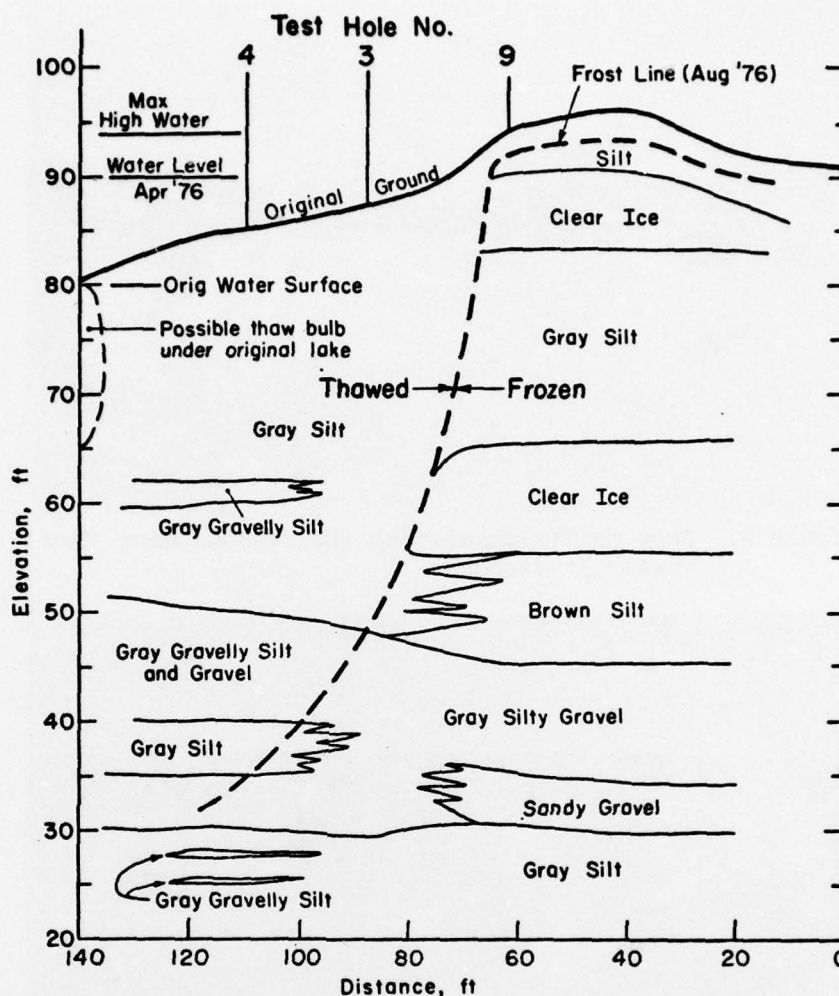
The depth of the thaw bulb beneath the reservoir was not measured at this time; however, it must be less than 47 ft, since all of the thermocouples installed behind the dam show that the portions of the dam which are being measured are below freezing. The thermocouple readings along with the probing and drill logs show that the dam is frozen and is in no immediate danger of failure. All presently observable problems are confined to the south abutment where the embankment adjoins at the south end. No signs of failure or stress of any kind could be found in the embankment of the dam or the north abutment. A composite cross section of the south abutment shows the probable extent of the thaw bulb underneath the reservoir (Fig. 8).

Figure 8. Thaw bulb in Vortac Dam south abutment.

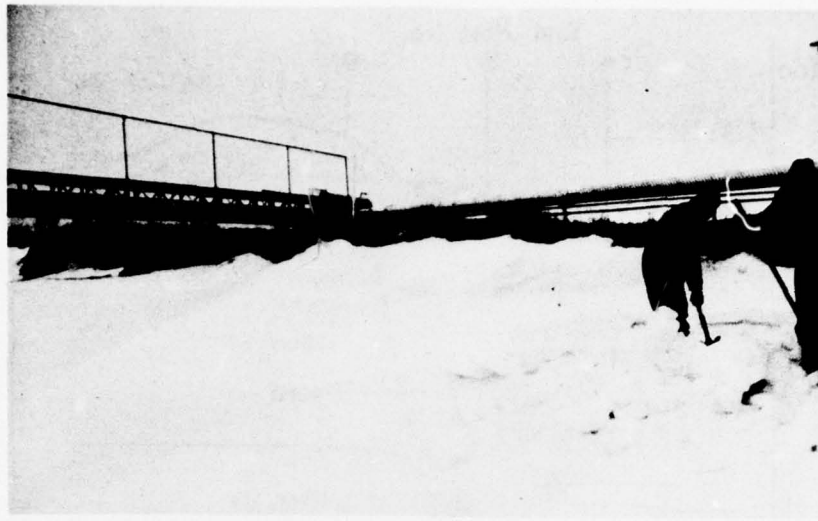
The continual raising and lowering of the water level is detrimental to the performance and lifetime of the embankment. Each time the water level is raised, heat flows into this newly inundated portion causing melting and slumping. When the water level subsides, this area is left to come to equilibrium with the atmospheric conditions which in summer are more conducive to continued melting rather than any refreezing. It would, therefore, be desirable to maintain as stable a water level as is practical (without hindering use of the dam as a water supply). It would also be desirable to maintain a low water level during the winter months so that areas in the embankment could be allowed to refreeze. However, refreezing may be thwarted by the large snow drifts that accumulate on the upstream side of the dam. These drifts effectively insulate the embankment from the winter temperature extremes, and much of the desired freezing (Fig. 9).

*Figure 9. Snow drifts insulating the slumped area from winter freezeback.*

2. The area around the dam should be cleaned up. Piles of gravel are sitting on the dam crest where they serve no useful purpose and cause snow drifting, which insulates the embankment from the winter cold. In addition, a good deal of debris from construction is scattered around the area and serves only to insulate portions of the embankment that should

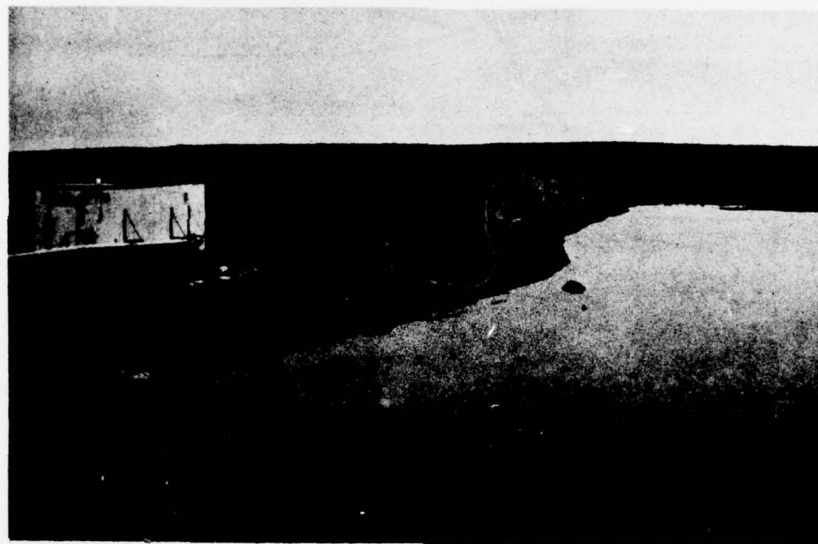
The last cross section is in the man-made portion of the dam north of the boiler plant. The difference in slope on both faces of the dam is apparent when comparison is made with the first four cross sections.

*Figure 10. Man-made embankment.*

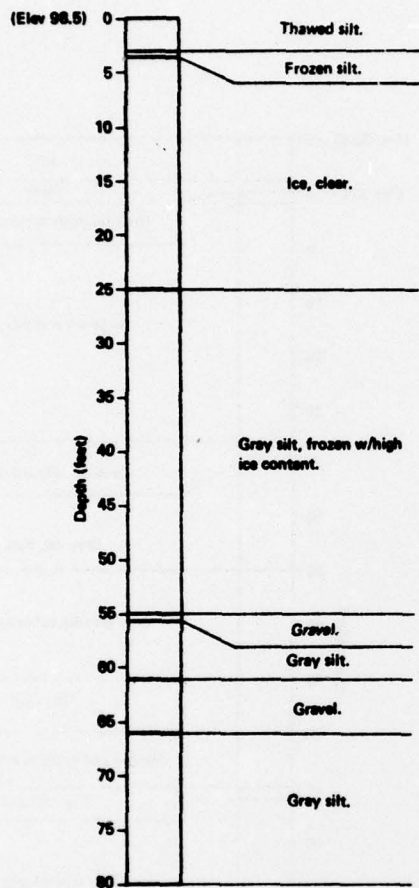
Figure A5. Drill log for hole no. 5.

5. Traffic along the frost-susceptible portions of the dam should be restricted as much as possible to minimize melting of the massive ice formations that are near the surface and extend to considerable depth (Fig. A5, A6, A9, App. A). Access areas should be adequately protected from damage due to traffic by either catwalks or insulated roadway embankments. This is particularly of concern in the vicinity of the south abutment.

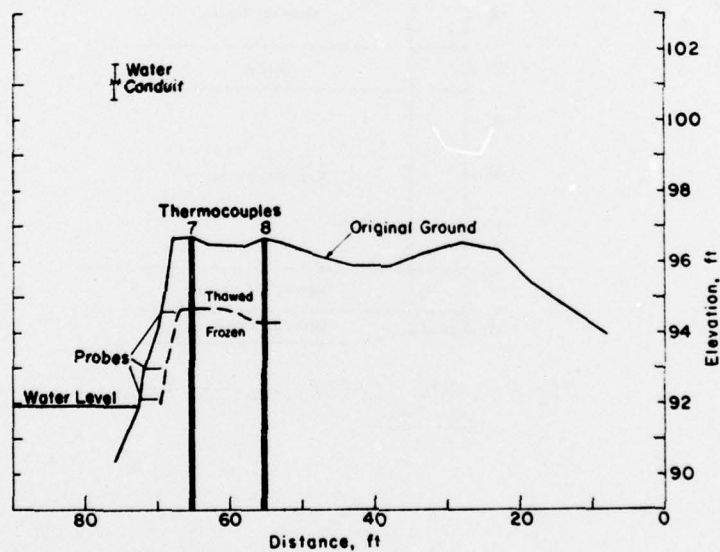
Figure B2. Cross section no. 2.

Five cross sections were made across the dam (see Fig. 2 for locations). Figures B1-B5 (App. B) show these cross sections. The cross section shown in Figure B2 gives the location of permafrost probings which were made in the near vertical upstream bank of the dam abutment and shows the zone of thawed material.
